# USS COLE

**Situation:** Suicide bombers attack US Navy destroyer with water-borne IED.

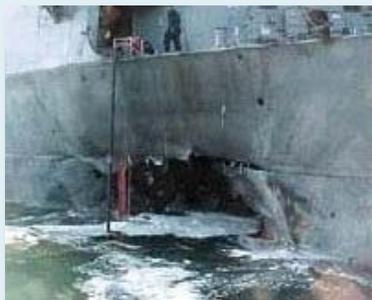
The terrorist boat exploded at 11:18 a.m. The blast tore a 40-by-40 foot hole in the USS Cole's half-inch reinforced steel plated hull. The vessel's interior also suffered massive damage; vessel bulkheads imploded, two lower decks were driven upward toward the surface deck, fuel lines ruptured, an engine room flooded, and power throughout the vessel went out.

To save the vessel from sinking, crewmembers improved the efficiency of onboard water pumps. At extreme risk to individual safety, torches were used in areas contaminated by fuel and oil to cut holes in the vessel hull slightly above the waterline. Hoses were then run out through the lower holes, as opposed to the interior of the vessel, to improve the efficiency of the water pumps. All activities to save the vessel and crew took place in extremely dangerous circumstances, with sporadic communications, and limited direction from vessel officers.
